Inspection Report

555 My New Home Road, Lexington, VA 23456

**Rockbridge Inspections
LLC**

Inspector: Randy & Jeannette Gibson VA-3380001560
230 Tall Wood Trail
Rockbridge Baths, VA 22473
10/22/2019

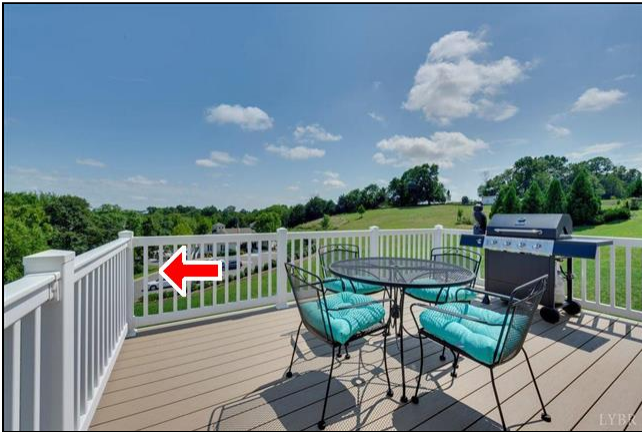
2.3 Item 1(Picture)

2.3 Left side deck post anchor is missing lag bolt. Recommend general handy man repair to keep post and railing from breaking away from deck.

This is a safety hazard for anyone leaning on the railing.

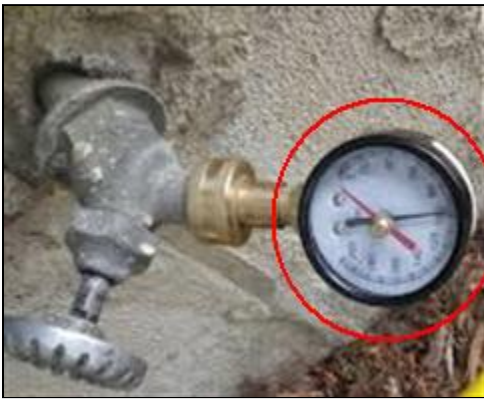
2.7 Item 1(Picture)

2.7 Outside hose bib pressure reading is 100 PSI. Recommend a pressure reducing valve as water pressure shouldn't exceed 80 PSI due to strain on plumbing fittings.

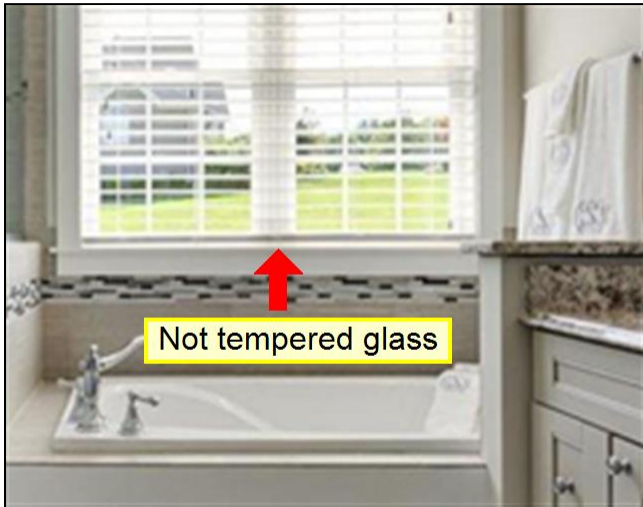
8.4 Item 1(Picture)

8.4 Master bathroom window over tub needs to be tempered glass for safety reasons. Recommend a licensed carpenter to replace window.

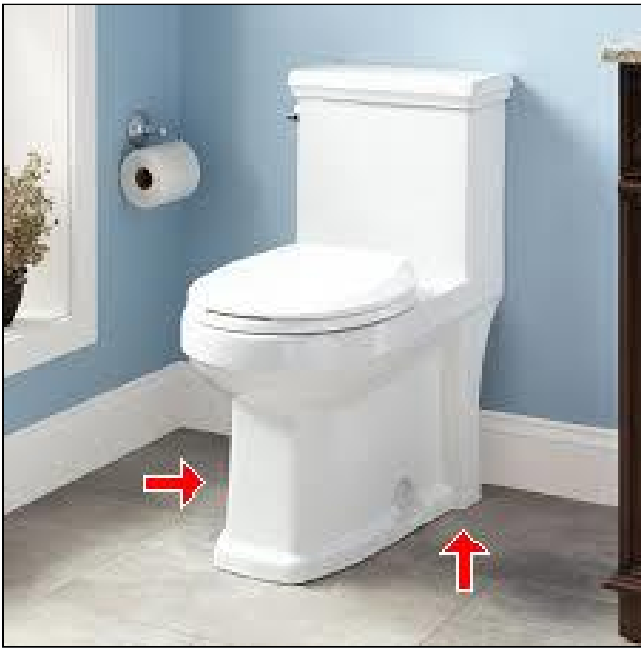
9.10 Item 1(Picture)

9.10 Loose toilet base. Recommend a general handyman replace wax ring and tighten securely to floor.

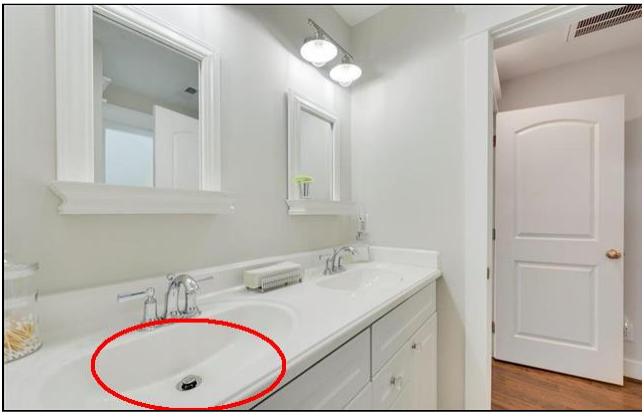
10.0 Item 1(Picture)

10.0 Left sink in bathroom 2 drains slowly. Recommend trying a drain cleaner to see if clog is hair build up in drain.

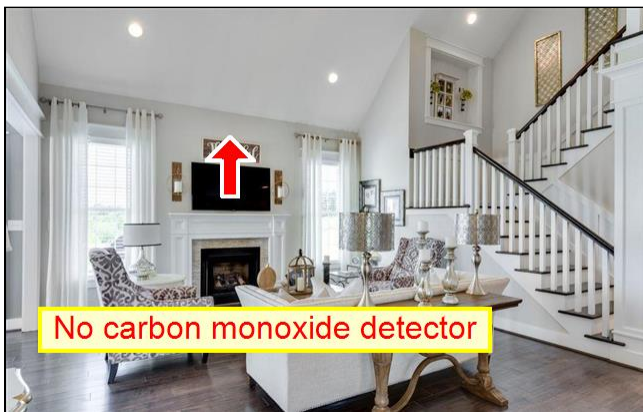
11.0 Item 1(Picture)

11.0 Recommend installing carbon monoxide detectors over all gas fireplaces.

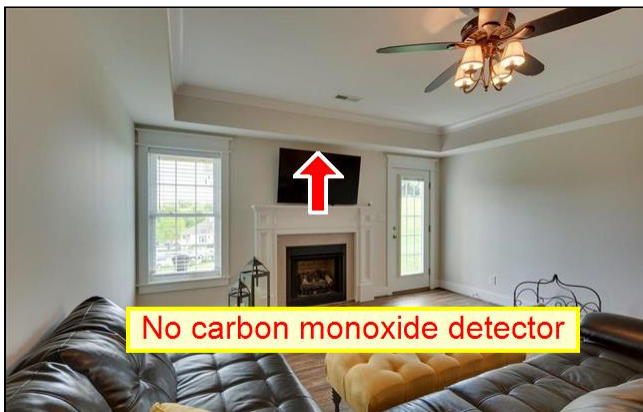
14.7 Item 1(Picture)

14.7 Recommend installing carbon monoxide detectors over all gas fireplaces.

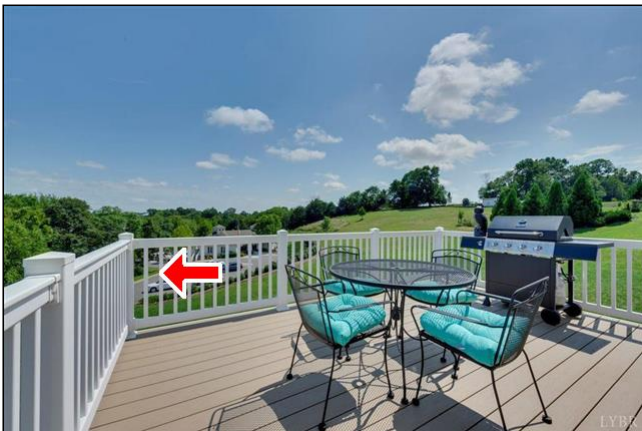
2.3 Item 1(Picture)

Left side deck post anchor is missing lag bolt. Recommend general handy man repair to keep post and railing from breaking away from deck.

This is a safety hazard for anyone leaning on the railing.

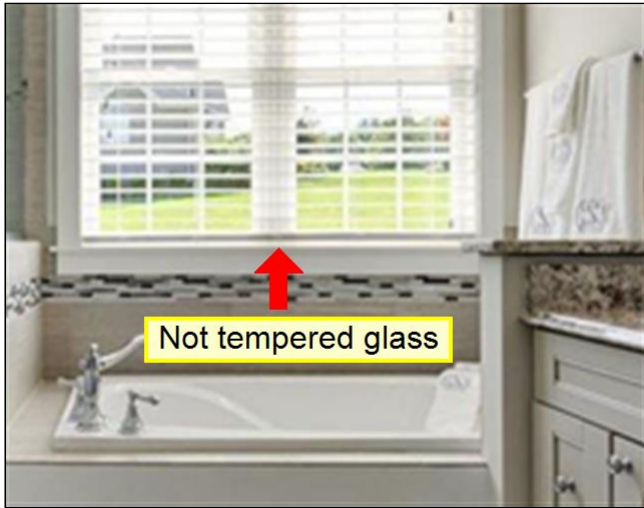
8.4 Item 1(Picture)

Master bathroom window over tub needs to be tempered glass for safety reasons. Recommend a licensed carpenter to replace window.

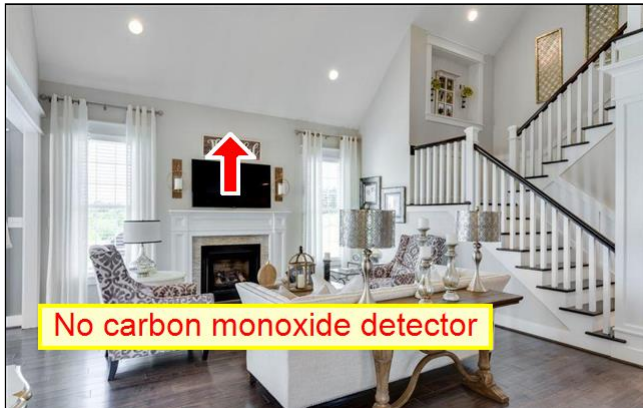
11.0 Item 1(Picture)

Recommend installing carbon monoxide detectors over all gas fireplaces.

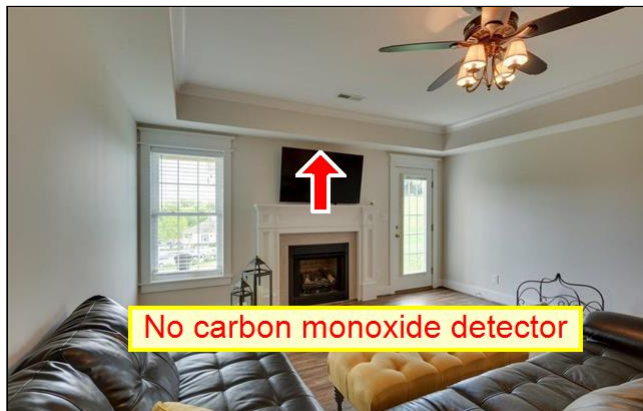
14.7 Item 1(Picture)

Recommend installing carbon monoxide detectors over all gas fireplaces.

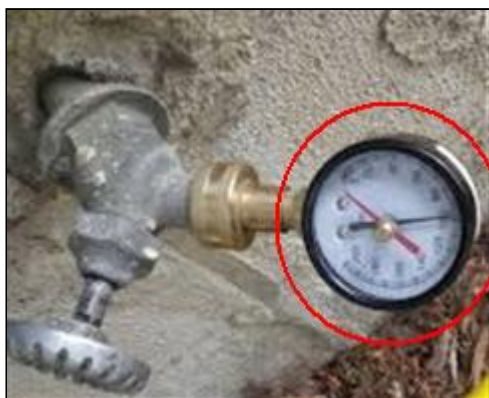
2.7 Item 1(Picture)

Outside hose bib pressure reading is 100 PSI. Recommend a pressure reducing valve as water pressure shouldn't exceed 80 PSI due to strain on plumbing fittings.

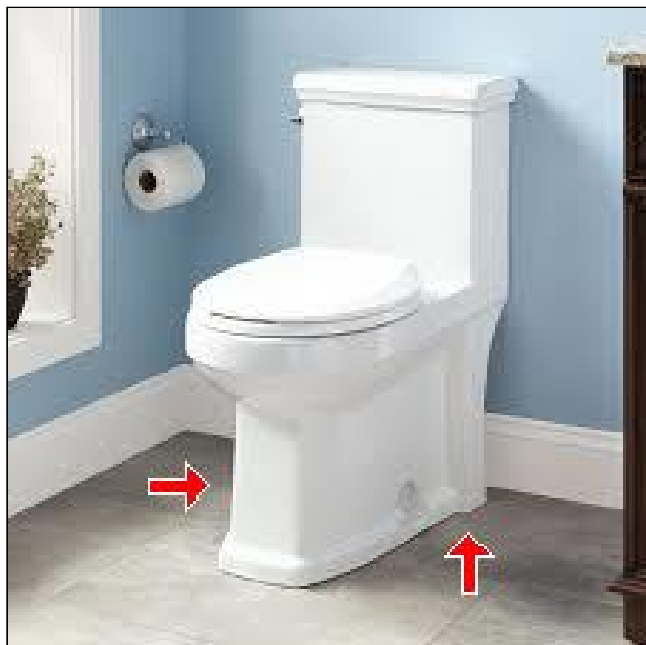
9.10 Item 1(Picture)

Loose toilet base. Recommend a general handyman replace wax ring and tighten securely to floor.

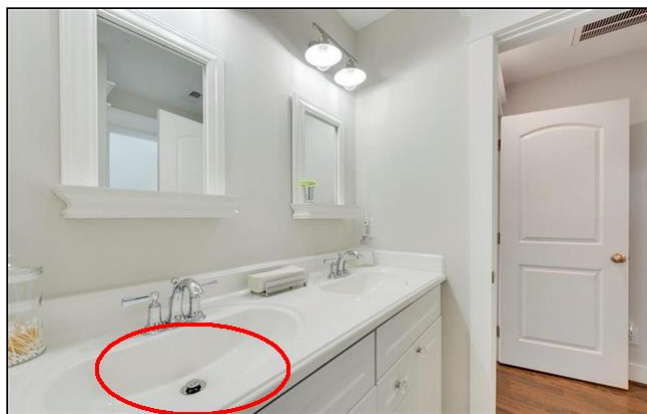
10.0 Item 1(Picture)

Left sink in bathroom 2 drains slowly. Recommend trying a drain cleaner to see if clog is hair build up in drain.
